a. The Accident. F-4B, BUONO 148401, assigned to MARINE FIGHTER ATTACK SQUADRON THREE ONE TWO (VMFA-312) stationed at Marine Corps Air Station (MCAS), Beaufort, North Carolina, crashed and burned approximately one mile short of runway 22 MCAS, Beaufort on 29 January 1968 at 1618 (R). The pilot, MAJ (b) (6) USMC, (b) (6) and the Naval Flight Officer (NFO), 1ST LT (b) (6) USMC, (b) (6) successfully ejected, however, the latter received major injury. The aircraft sustained ALFA damage. There was minor damage to government property and no damage to private property.

a. The most probable cause of this accident was the failure of the bleed air duct transition section, P/N 10624-22. The cause of the failure was fatigue originating in the welds.

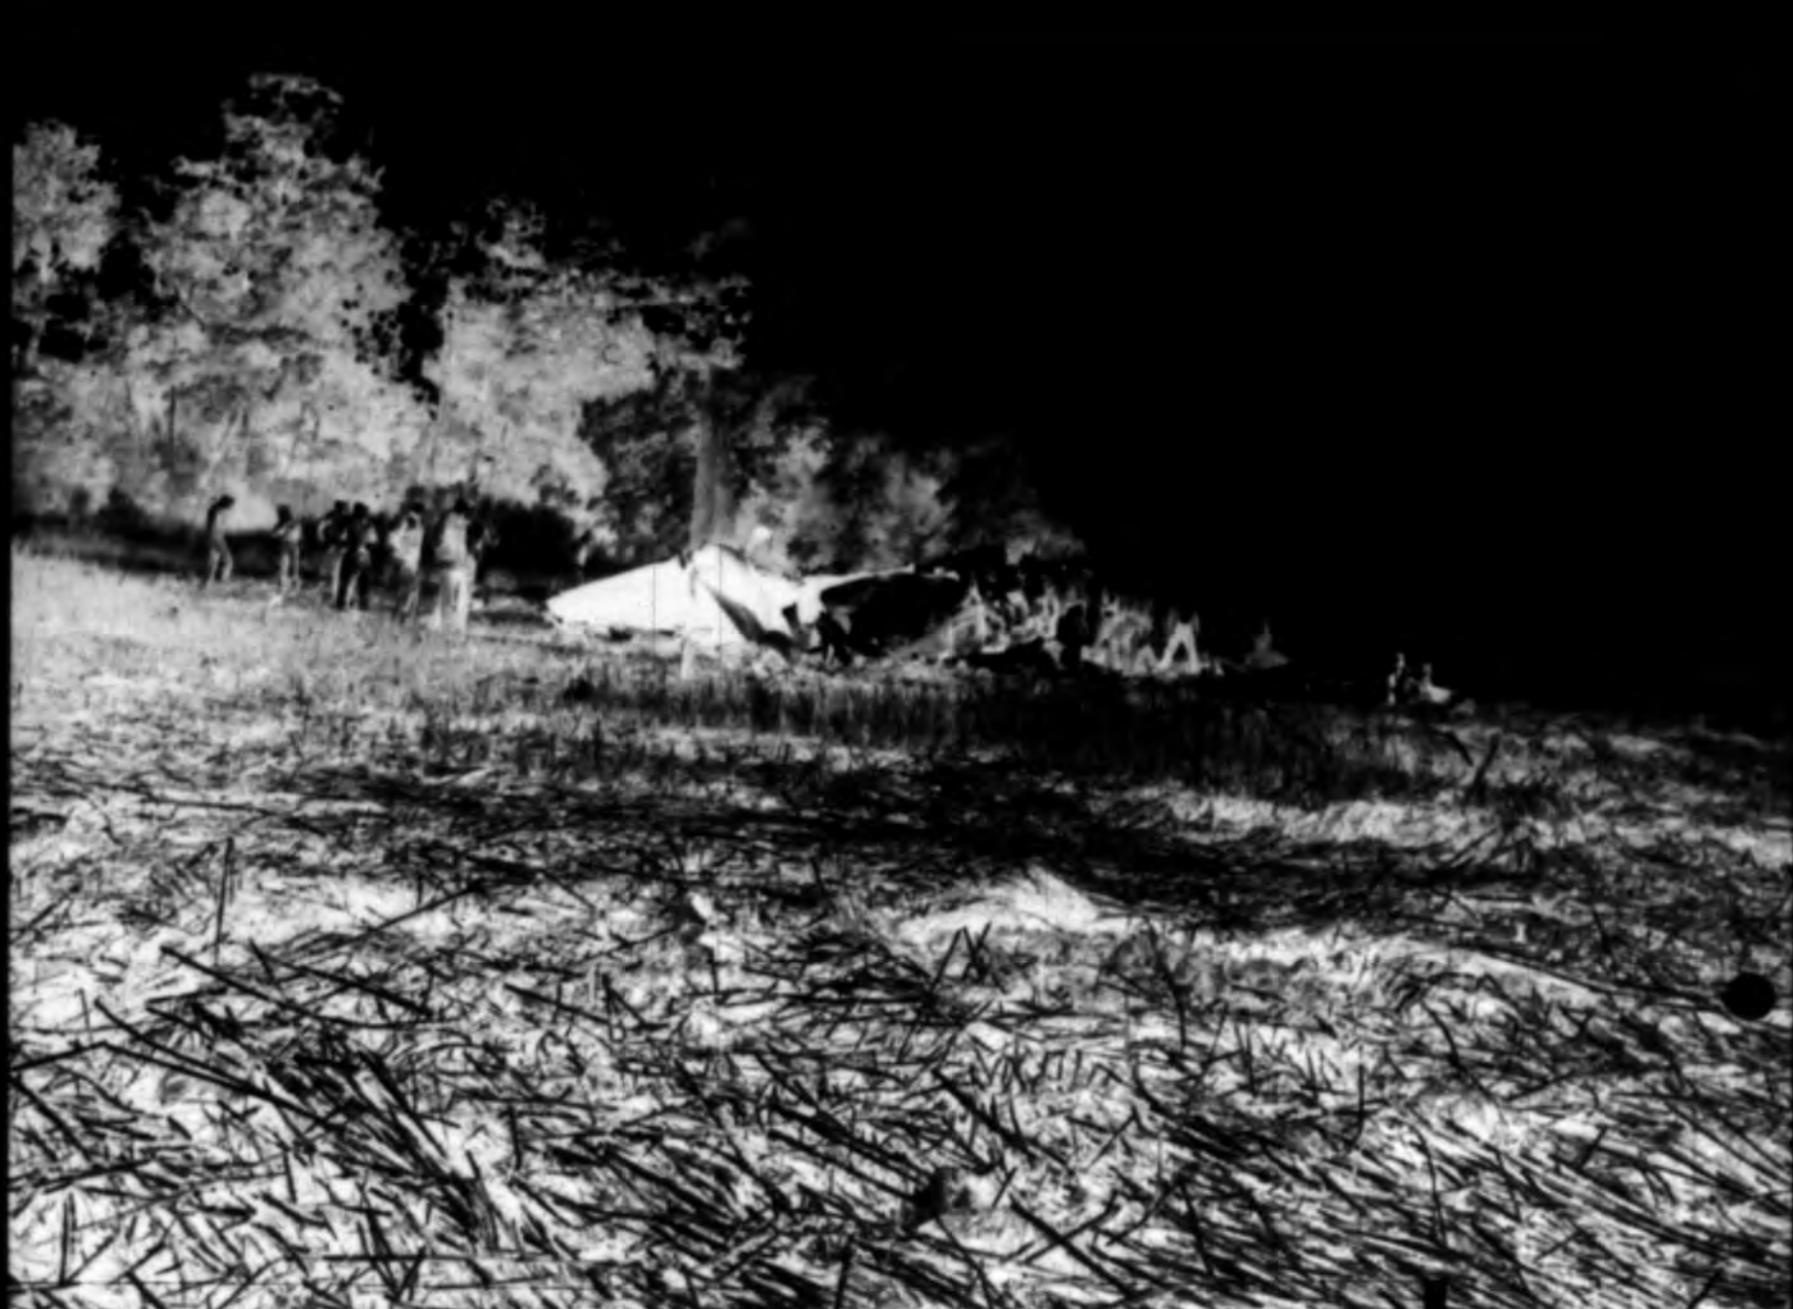
SIDE VIEW OF WRECKAGE SHOWING ONE TWO LARGEST
PORTIONS OF WRECKAGE THE TAIL (LEFT) AND ENGINES (RIGHT).
SPECIAL HANDLING REQUIRED IN ACCORDANCE WITH OPNAVINST 3750.6 SERIES
ENCLOSURE (16)

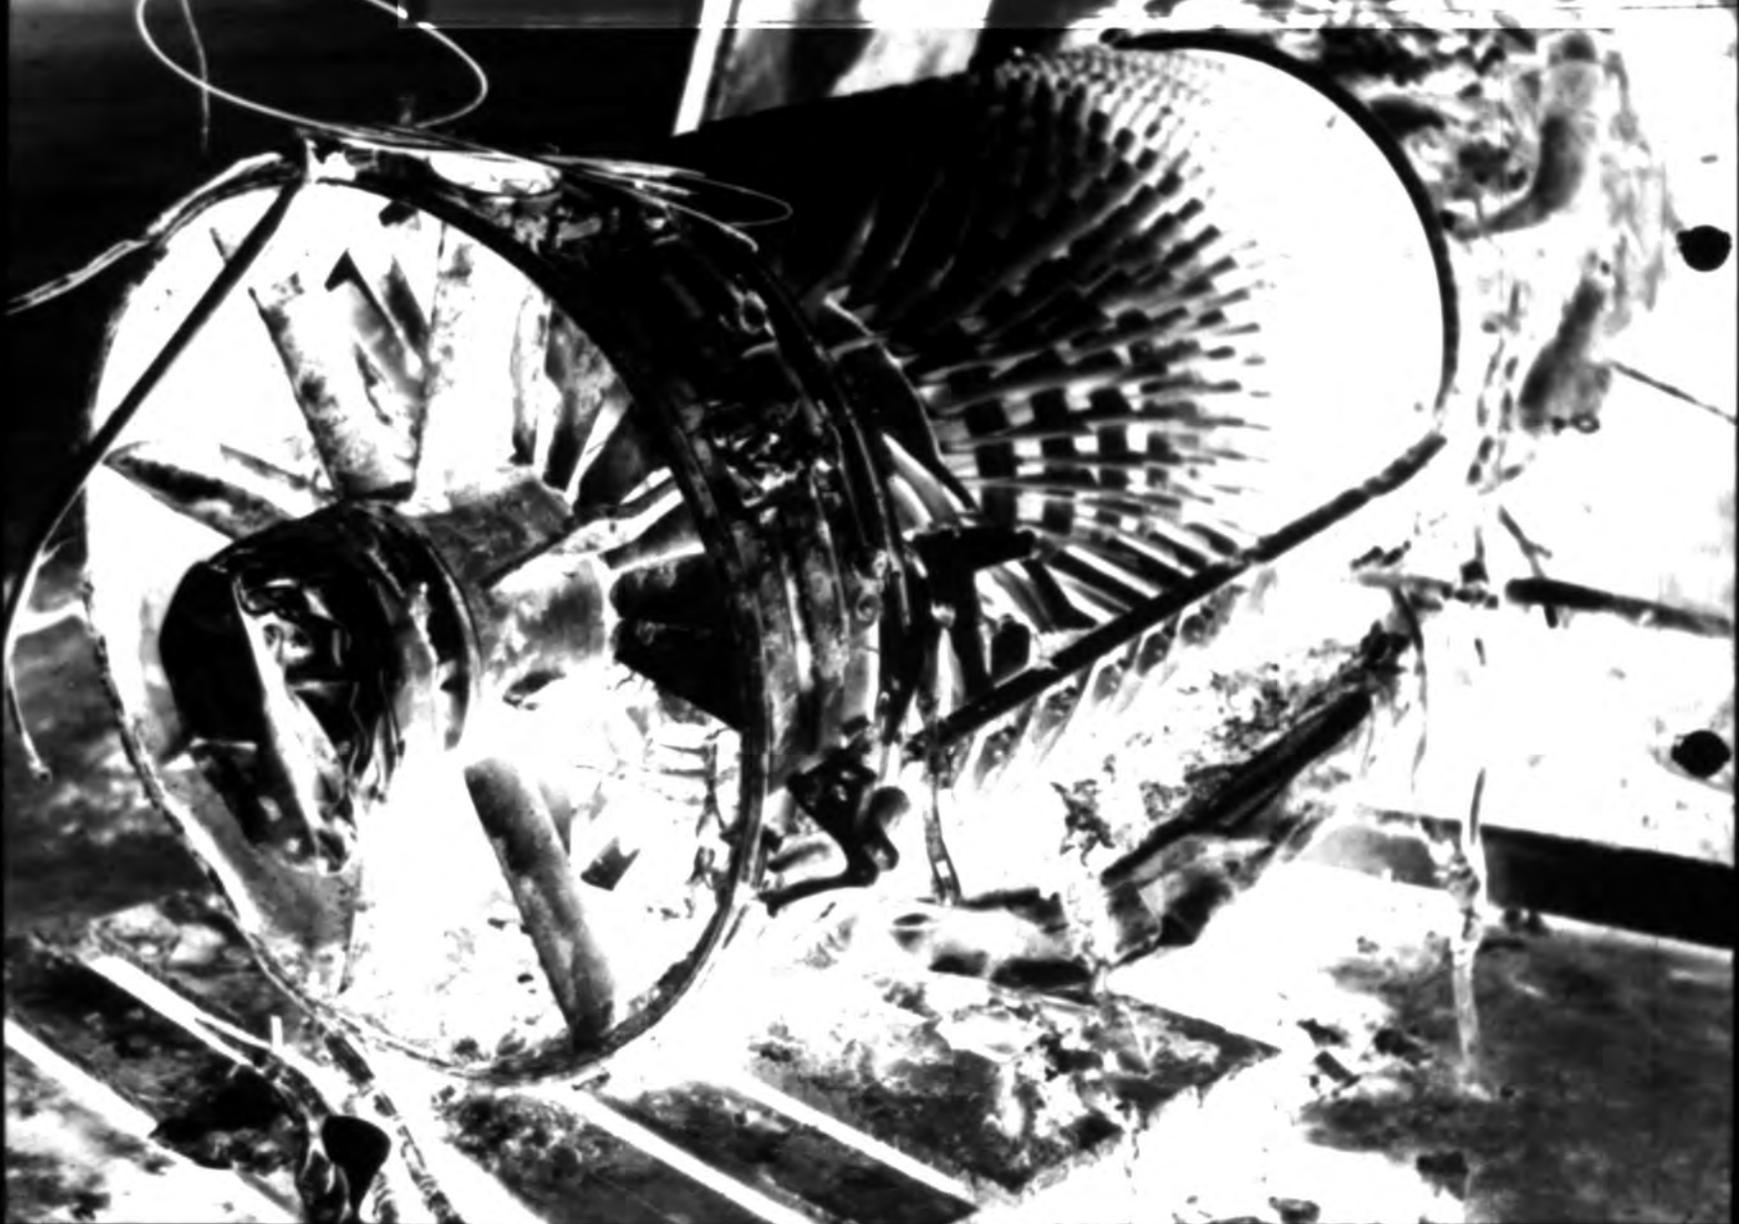
(a) The port engine was not operating at impact. The pilot stated he had secured the engine in the air because of a fire warning light. There was no evidence to indicate any component failure or in-flight fire.

VIEW OF LEFT ENGINE WITH COMPRESSOR CASE
REMOVED. NOTE NO ROTATIONAL DAMAGE
SPECIAL HANDLING REQUIRED IN ACCORDANCE WITH OPREP-50.F SERIES
SERIES (21)
